Eisenberg, February 26th 2018

Safety note concerning: Deployment bags for reserve parachutes

Status: OBLIGATORY

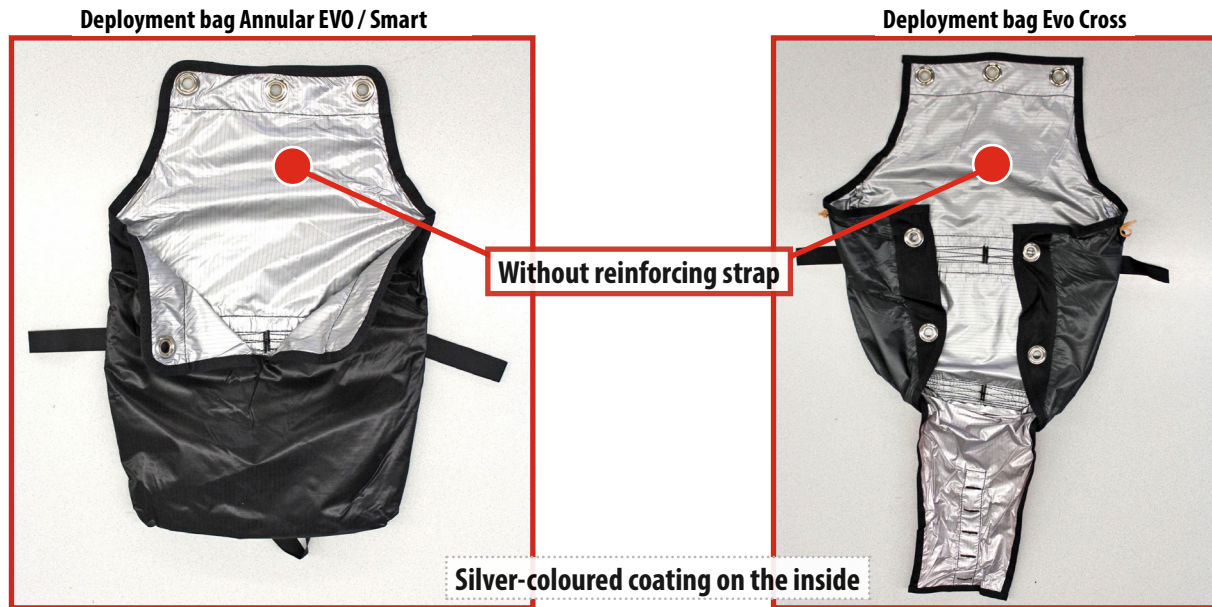
CONCERNED DEPLOYMENT BAGS

At the seam-line of the isolated upper loop, which is used to attach the deployment handle, a perforation could possibly cause a material weakening of factory delivered deployment bags. This seam-line, if properly processed, has to be able to bear a load of 70 daN. Yet it was proven that a lower strength of this component can occur.

The affected deployment bags can be distinguished either by the year of manufacture or their serial number. The best visible indication which distinguishes concerned bags, is their silver-coloured coating on the inside of the deployment bag, if it does not have a reinforcing strap (as can be seen below).

The owners of affected deployment bags are obliged to check before flight, whether the **isolated upper loop** of the deployment bag is in use. If it is in use, the deployment bag needs to be replaced immediately!

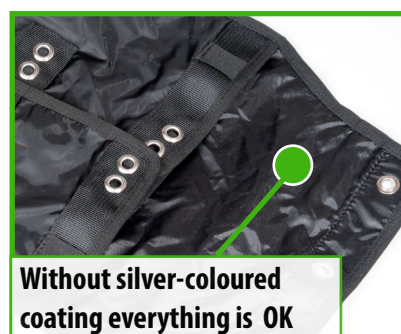
DEPLOYMENT BAGS NOT CONCERNED

Not concerned are earlier items which can clearly be recognised by the missing silver-coloured coating on the inside. Not concerned are all items which have been delivered as of February 2018. These new deployment bags are clearly marked with a check mark (OK) and can be recognised by the additional reinforcing strap on the inside. Furthermore deployments bags which have been delivered as component of a harness are not concerned.

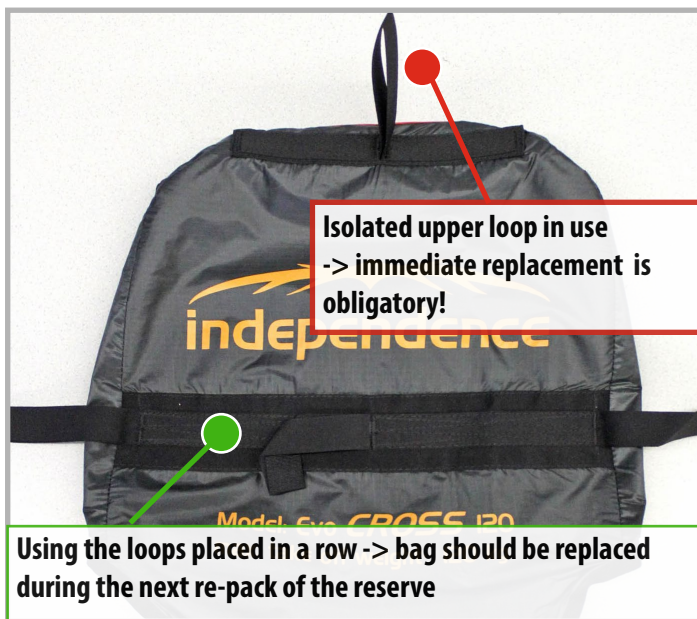
If one of the **three loops in a row**, which are placed between the labellings, is in use, the deployment bag does not necessarily need to be replaced. **These three loops don't show any faults and are not concerned by this safety note** (see image on the left).

If the isolated upper loop is in use, **immediate replacement** is obligatory!

If one of the lower 3 loops placed in a row is in use: Replacement should take place latest during the next re-pack of the reserve.
